SITE: E Seattle, WA

RE: Pruning one Japanese maple (*Acer palmatum*)

DATE: 10/28/2019

PROJECT ARBORIST: Allen Taylor

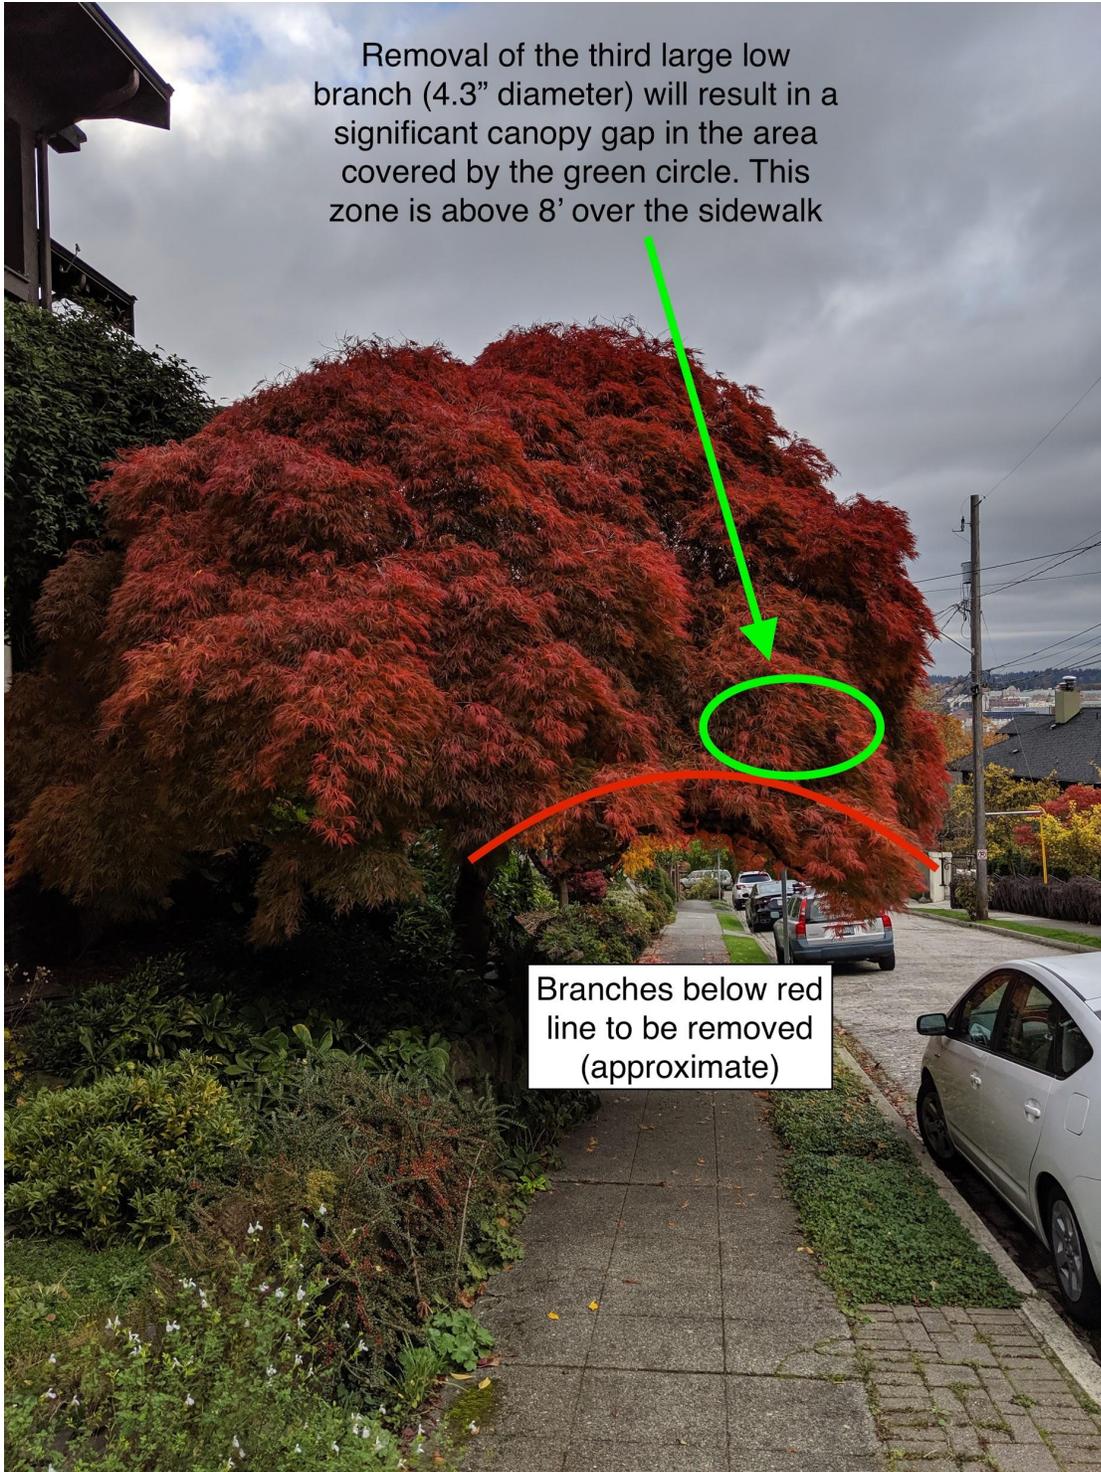
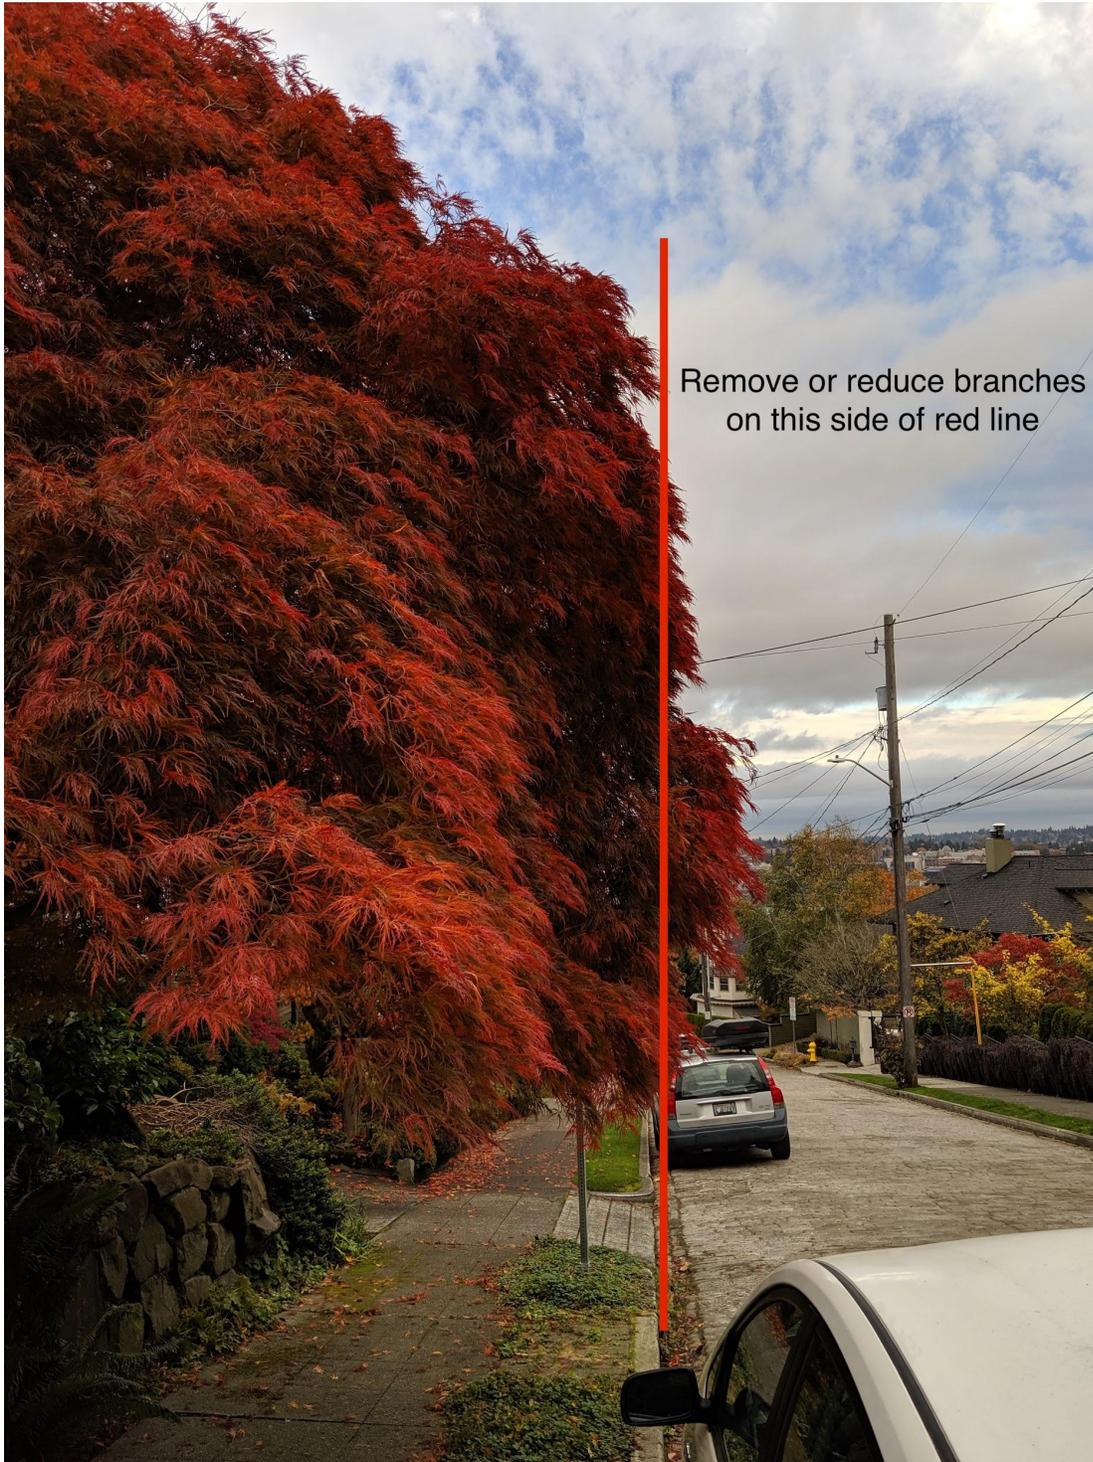
Appendix 1: Photos

The City of Seattle Department of transportation requires eight feet of clearance above a sidewalk and fourteen feet of clearance over the street.¹ There are three large low branches which are primarily growing within the sidewalk clearance zone. I propose that two of the three branches be removed. Other smaller branches (1" diameter and smaller) may also be removed or reduced to provide clearance. The current clearance is approximately five and a half feet above the sidewalk. The proposed pruning will improve the clearance to approximately seven and a half feet.

In my professional opinion the removal of the third branch will cause significant harm to the aesthetic beauty and value of the tree (see **Appendix 1: Photos**). Additionally it will subject the trunk to a third large wound. The subject tree is an exceptionally large and well formed specimen of a weeping cultivar of Japanese maple. It is one of the finest weeping Japanese maples I have observed during my career. Ms. O informed me that it had been nominated for landmark tree status.

- Remove two low east branches (3" and 4.2" diameter)
- Retain low 4.3" diameter east branch (7.5' above sidewalk)
- Reduce or remove other branches (1" diameter and smaller) as needed to provide 8' of clearance over the sidewalk
- Reduce or remove branches as needed to provide 14 feet of vertical clearance over the street
